TECHNICAL SERVICE BULLETIN

Aftertreatment Regeneration Recommendation

TSB200024: Early Life Turbo Failure following DPF Regeneration.

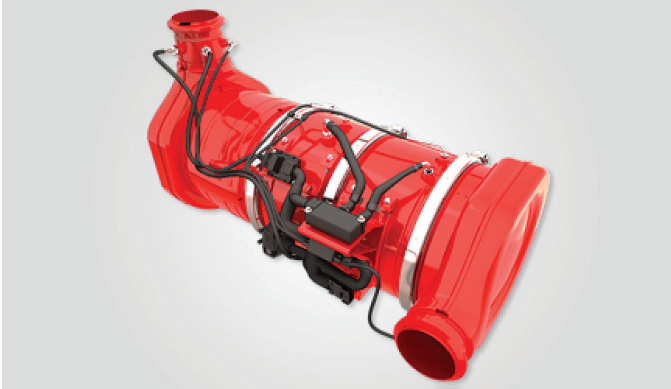
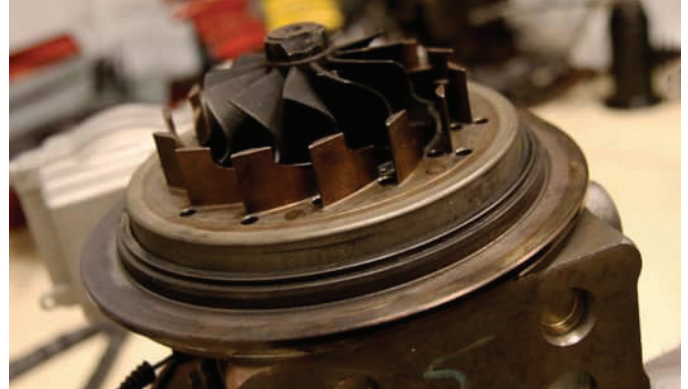
DO NOT REGEN RIGHT AFTER INSTALLING A VGT TURBO

- Regen causes high exhaust temperature which can burn the assembly oil on the VGT causing it to bind.
- Operate/road test the truck for at least 30 minutes prior to regeneration.
- Do not high or low idle for an extended period after turbo installation as the aftertreatment warm up process may start.
