VGT STICKING CAUSED BY FOREIGN OBJECT IMPACT DAMAGE (FOID)

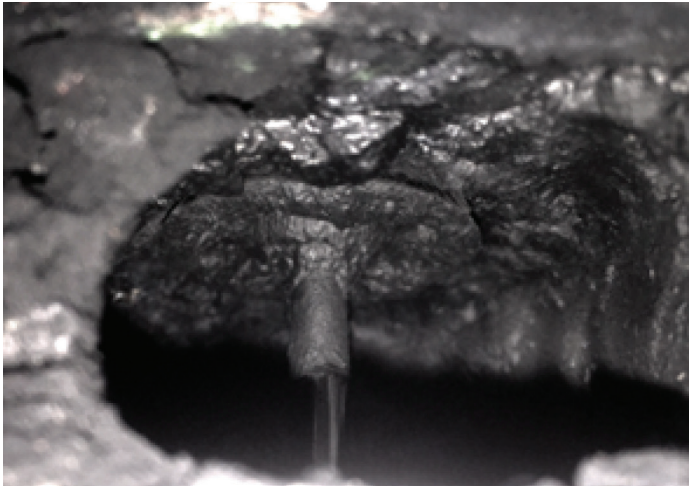
Carbon deposits from oil consumption, for example, the EGR valve.

- Check for carbon deposits
- Clear intake and exhaust passages after engine work

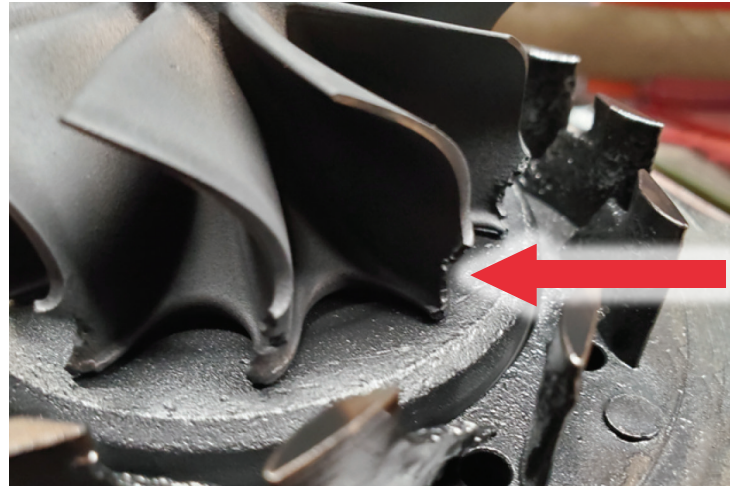
Machining debris left over from engine work.
