TECHNICAL SERVICE BULLETIN

Oil Filter Bypass Valve Must be Updated

APPLICATION INFORMATION: ALL ISM, QSM, ISX, QSX ENGINES

TSB160017 New Oil Bypass Valve
4908439 Installation Instructions

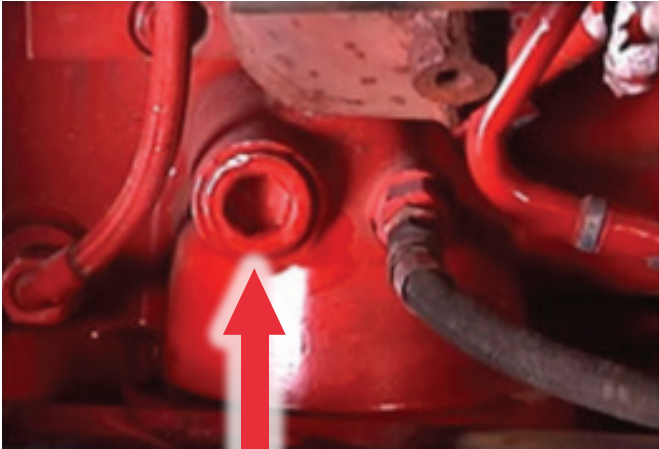
NEEDS UPDATE PERFORMED

NO PAINT:
needs update performed.

Failure to update the bypass will allow unfiltered oil into the turbocharger bearings and cause it to fail, voiding the warranty.

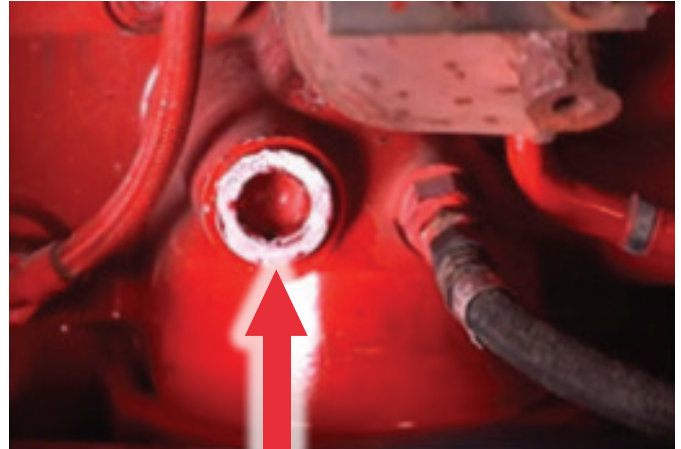
UPDATED

PAINT:
revised bypass has been installed.
